ERA26FA309

On August 19, 2026, at 1852 eastern daylight time, a Bell Helicopter Textron Canada 407, N873ST, and a Cessna 150H airplane, N23330, collided in flight near Carlisle, Pennsylvania. The two commercial pilots onboard the helicopter were seriously injured, and the helicopter was substantially damaged. The commercial pilot on board the airplane was fatally injured and the airplane was destroyed. The helicopter was operated by the Pennsylvania State Police (PSP) as a public aircraft. The airplane was operated as a Title 14 *Code of Federal Regulations* Part 91 personal flight.

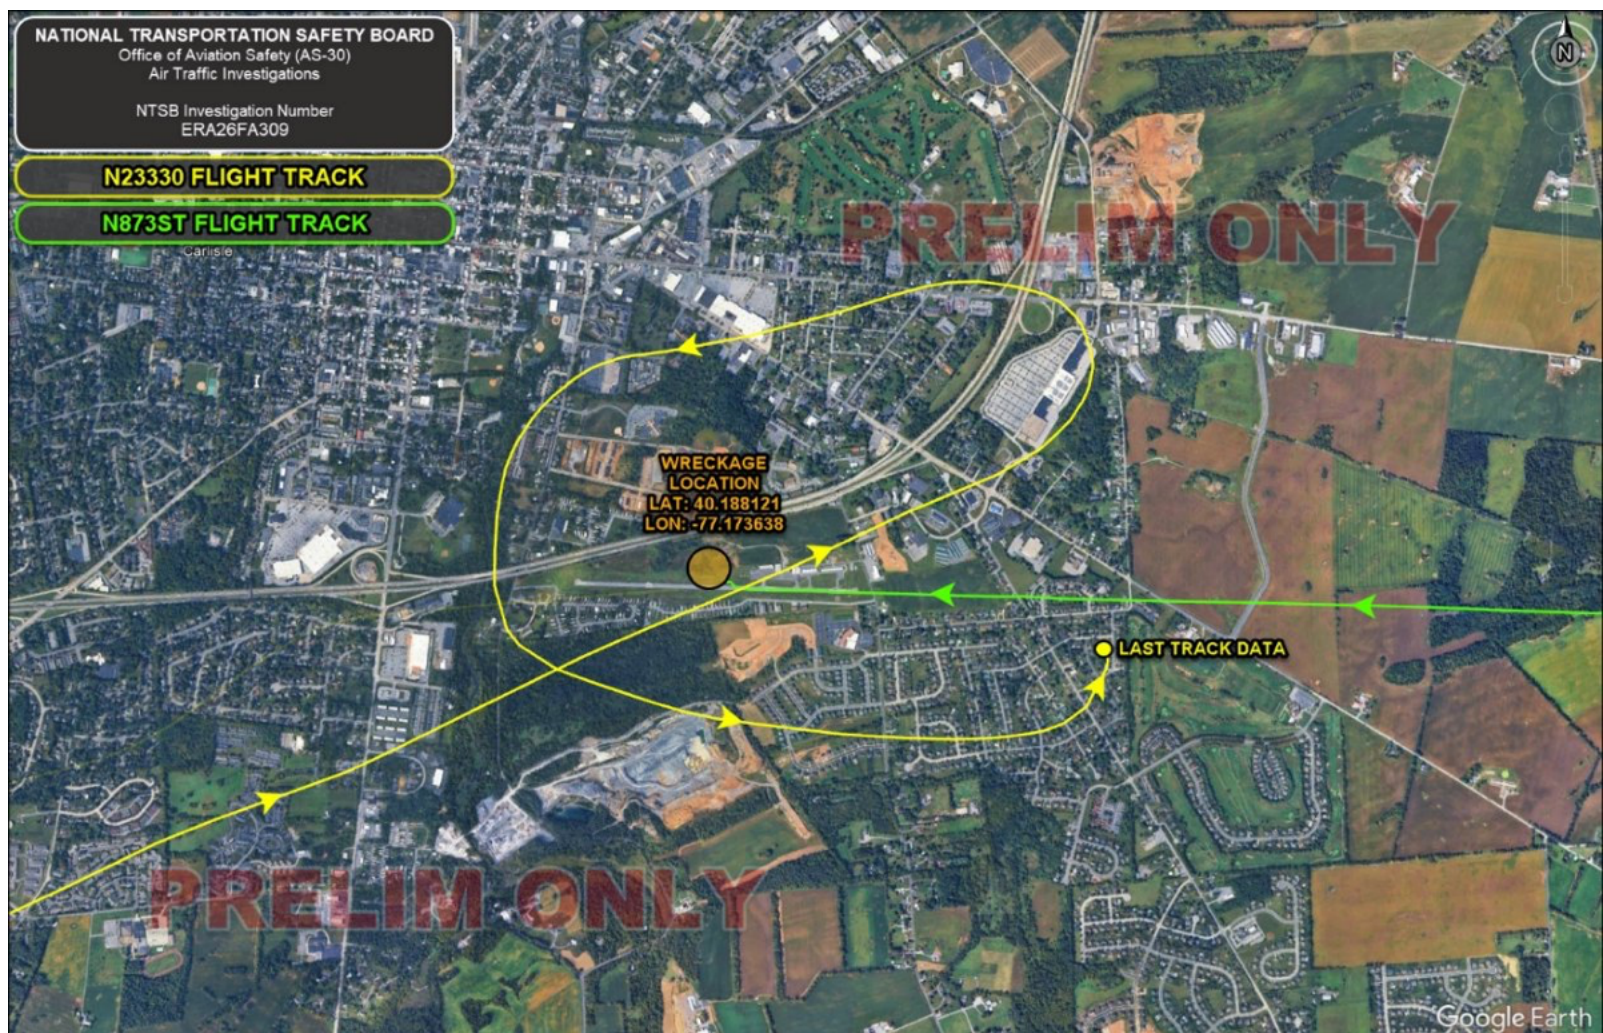
While the helicopter was approaching the airport, ADS-B data showed that the airplane crossed over the airport to the northeast, then made left turns to enter a left crosswind leg to downwind leg of the traffic pattern for runway 28 (figure 1). A witness stated that he heard the airport Common Traffic Advisory Frequency (CTAF) communications between the helicopter flight crew and the airplane pilot; one of the helicopter pilots told the airplane pilot to extend his downwind. The airplane pilot acknowledged the communication.

Figure 1 – ADS-B flight track data for the helicopter (green) and airplane (yellow) during their approaches to the airport.

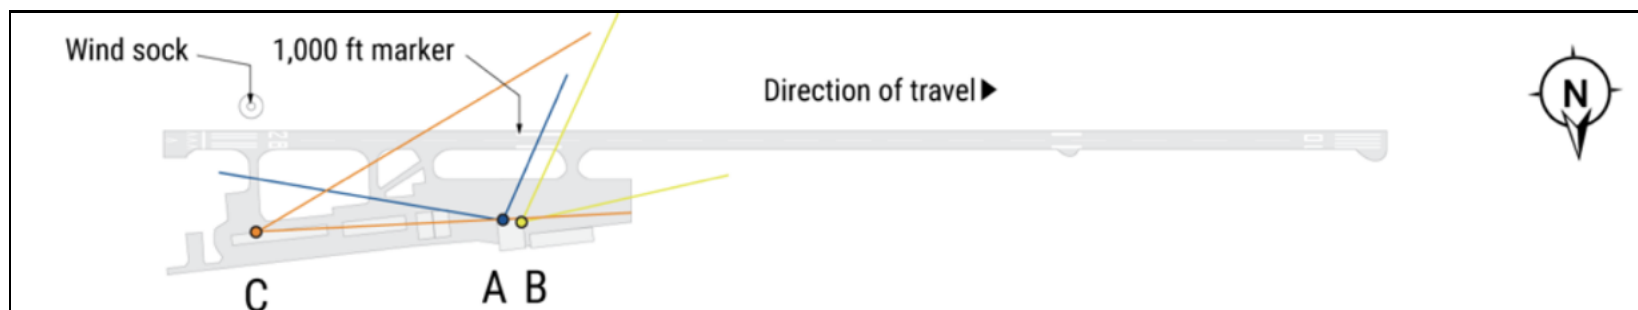
There were three security cameras on the airport that captured the aircraft immediately before and during (figure 2) the approach of both aircraft. Timestamped airport security camera footage showed the helicopter on short final approach to runway 28. The helicopter crossed over the runway threshold while the airplane was on the left base leg. About 30 seconds later, the airplane crossed over the threshold as the helicopter was still over the runway. The airplane's wings rocked to the left and right as the airplane flew low over the runway surface, and it appeared to make several lateral and vertical movements as it flew over the runway with the flaps extended. The airplane did not touch down on the runway. As the airplane approached the helicopter, the helicopter hovered off the runway and transitioned over the grass field, with its nose still oriented toward the departure end of runway 28 and parallel to the runway. The helicopter pilots stated that due to the helicopter's position and orientation relative to the runway, they were unable to observe the approaching airplane, which was behind them.

Figure 2: Airport security camera locations labeled A, B, and C, showing their orientation relative to the airplane and helicopter's direction of travel down runway 28.

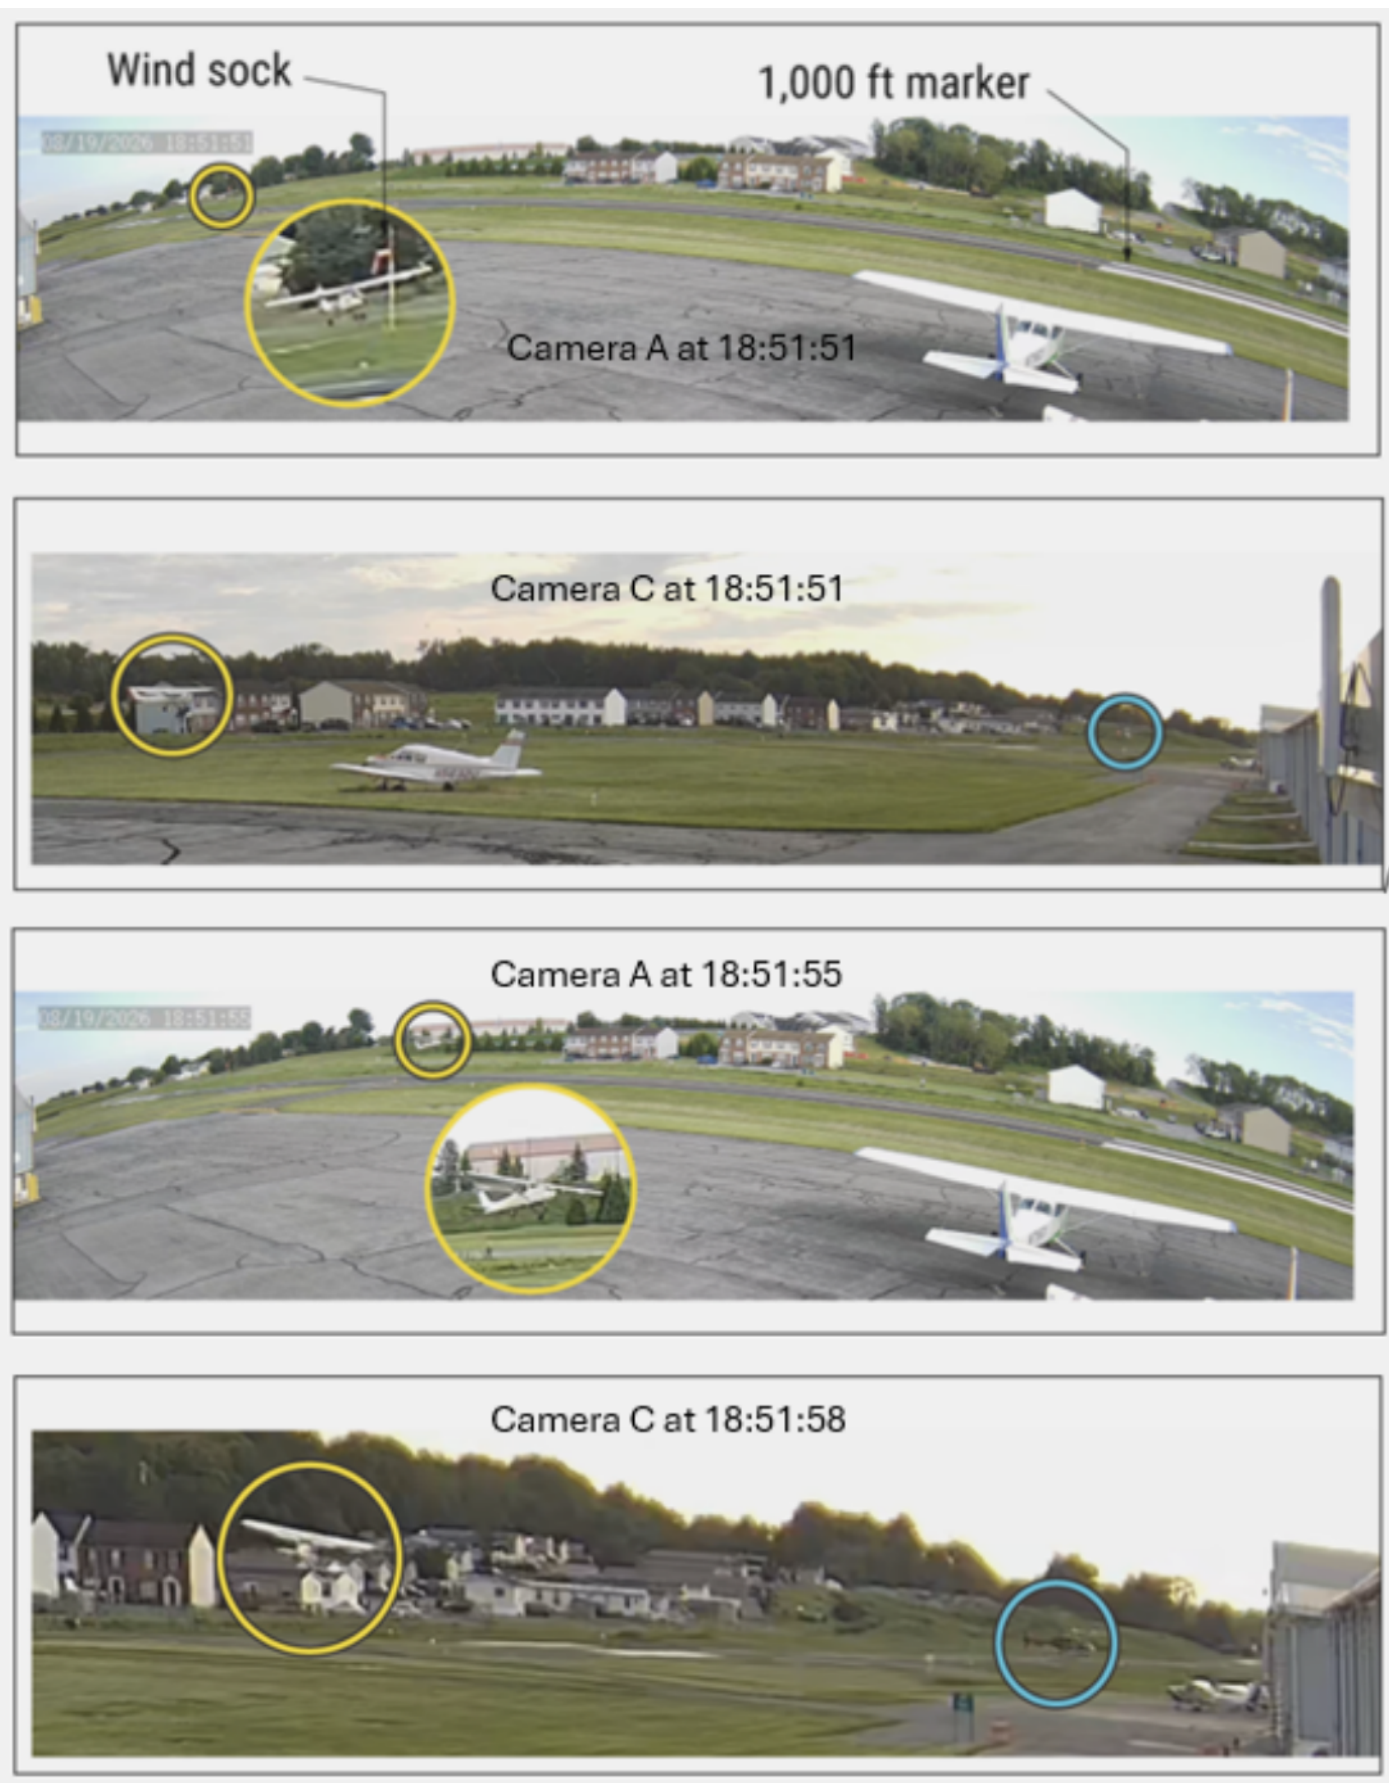
The airplane continued to fly along the runway with the wings rocking before it pitched up and began climbing. After the airplane reached the apex of its climb, about 1 1/2 wingspans above the runway, the right wing dropped and the airplane immediately turned right and descended towards the northwest. The helicopter was in a hover about 50 ft north of the runway when the approaching airplane's wings rolled level, before it rapidly pitched up, and collided with the rear of the helicopter, striking the tail rotor and main rotor blades. About 8 seconds elapsed from the time the helicopter exited the runway surface until the collision.

Figure 3 Four still video images from cameras A and C showing the airplane and helicopter as they maneuvered in the vicinity of the runway. The airplane is circled in yellow, and the helicopter is circled in blue.
