Aviation Investigation Preliminary Report

Location:	Laredo, TX	**Accident Number:**	CEN26FA228
Date & Time:	June 16, 2026, 22:00 Local	**Registration:**	N523QS
Aircraft:	TEXTRON AVIATION INC 680A	**Injuries:**	1 Fatal, 1 Serious, 5 Minor
Flight Conducted Under:	Part 91 subpart k: Fractional

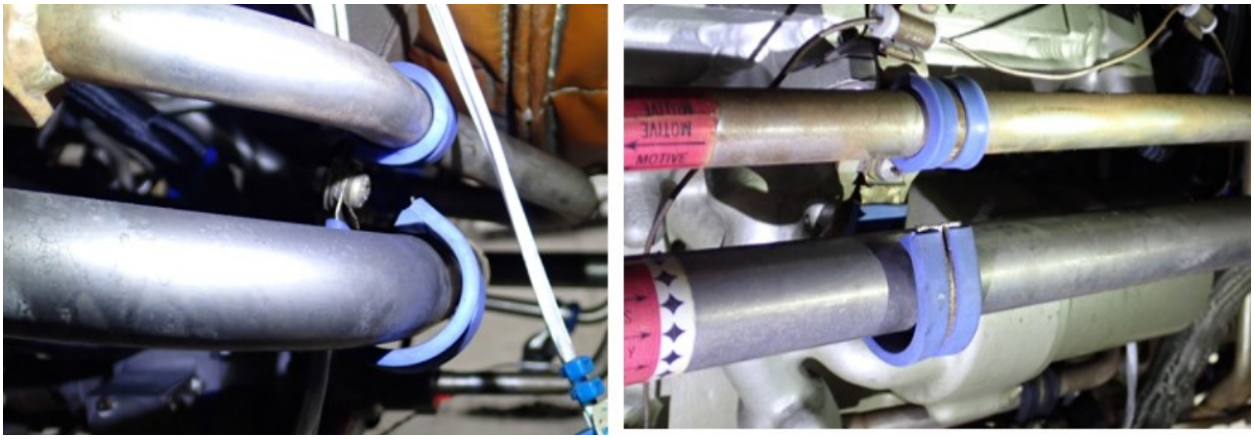
Figure 1. Right engine fuel tube assembly and fuel pressure switch

The airplane wreckage was initially recovered to a secure hangar at LRD for preliminary examination. During the examination, flight control continuity was established for the ailerons, elevator, and rudder. Further examination revealed that the right engine fuel pressure switch (part number 9914488-2) was found separated from the fuel tube assembly (part number 6956100-118) and the fuel tube assembly was fractured adjacent to the weld joint for the attachment tube leading to the fuel pressure switch as shown in Figure 1. Multiple P-clamps on the fuel tube assembly were also found fractured as shown in Figure 2.
